Manhole Inspection Summary

Manhole # S09II1012MH

Insp Date: **1/12/09 2:40 PM**

Location Address: **3605 WOODLAND AVE**

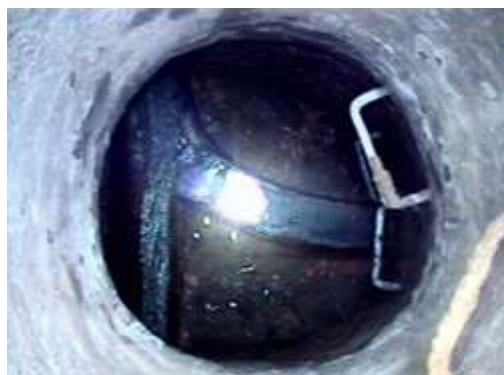
Defect 3

☒ **Evidence Of Surcharge**

Depth: **2** (ft.) ☐ Active Surcharge Present

EVIDENCE SURCHARGE

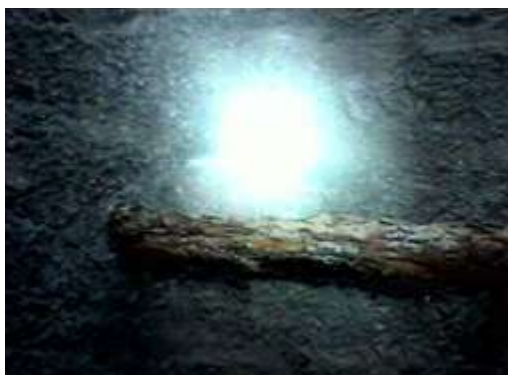
Defect 1

Count: **5** Missing: **0** ☒ **Corroded**

CORRODED RUNG

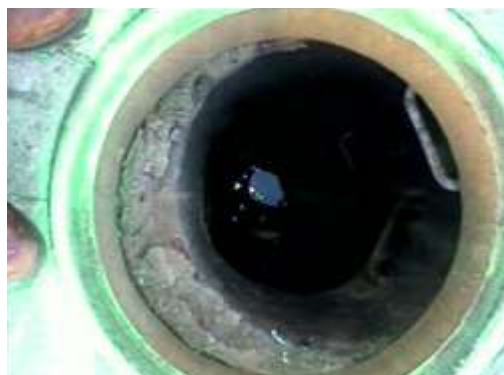
Defect 3

Offset: **4** (in.)

OFFSET FRAME

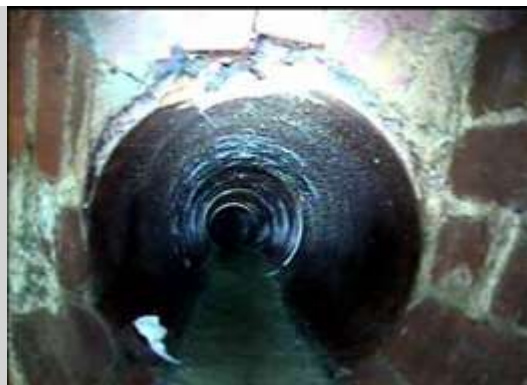
6 O'Clock Inflow

10 in. Circular Gravity Sewer
Pipe In @ 6 O'Clock

Infiltration: **None** Pipe Seal Cond: **Cracked**
